# *Warren Shire Council*

***DRAFT***  
***Pedestrian Access and Mobility Plan***  
***Report, November 2014***

*Accessible Public Domain*

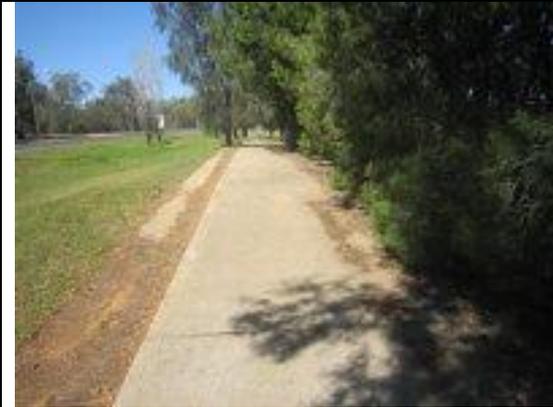
1. Trees overhang the Shared Path on the western side of Oxley Highway, between Zora Street and the Bridge over Gunninbar Creek.

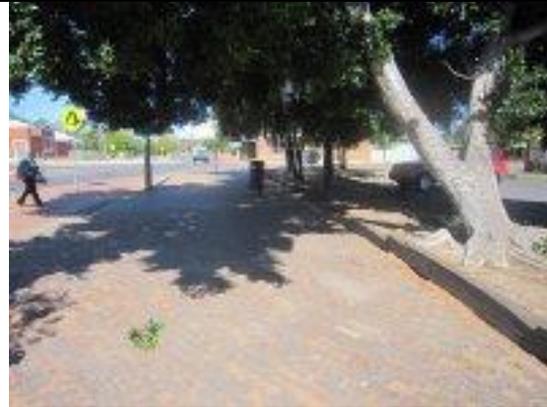
2. Low hanging tree, west side of the Oxley Highway, north of Dubbo Street.

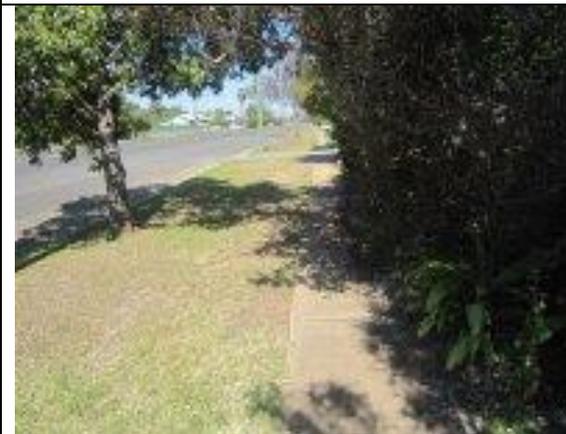
3. Shrubberty reduces the width of footways.

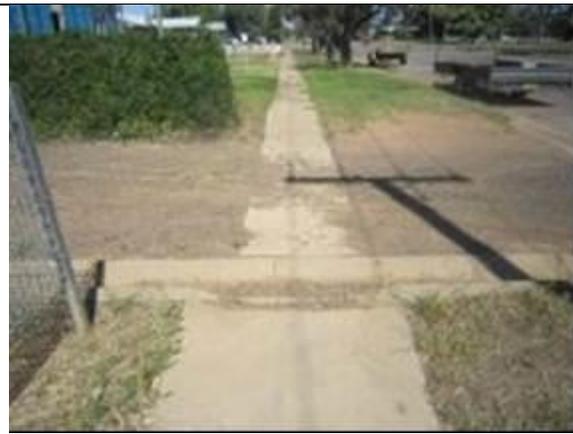
### **5.02 Loose Gravel (Photograph 4)**

Loose gravel on a firm surface is a fall hazard for all pedestrians. The removal of loose gravel by Council and residents from areas under their control is considered to be a high need, low cost action.

4. Loose gravel from a mid-block laneway creates a trip hazard for all pedestrians.

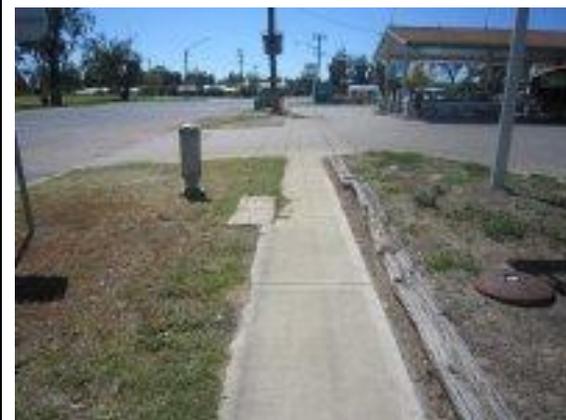
5. A kerb is required to separate the footway from the fuel lanes at Service Stations.

**5.03 Service Stations (Photograph 5)**

The driveways at some Service Stations are badly damaged across the footway and require reconstruction. Service Station proprietors should be required to provide barriers along the property line to protect pedestrians from vehicles in the ‘filling’ aisles, and to prevent damage to footways. The reconstruction by owners of damaged driveways, and the provision of barrier kerbs, are considered to be high-need, low-cost actions.

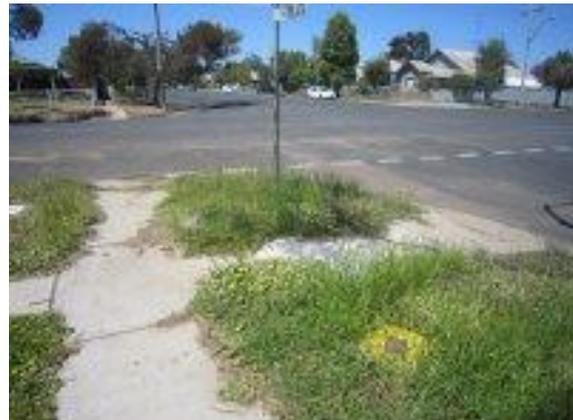
6. Grass overgrowth on footways is a potential trip hazard for people with vision impairment.

**5.04 Grass growth in footway joints and cracks (Photographs 6 and 7)**

Grass in joints and cracks poses a trip hazard for people with vision impairment and older people who do not lift their feet and tend to shuffle. The poisoning and removal of grass is considered to be a high need, low cost action.

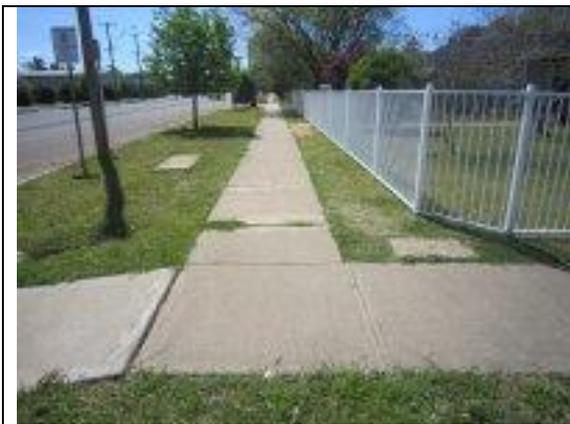
7. Grass in footway joint.

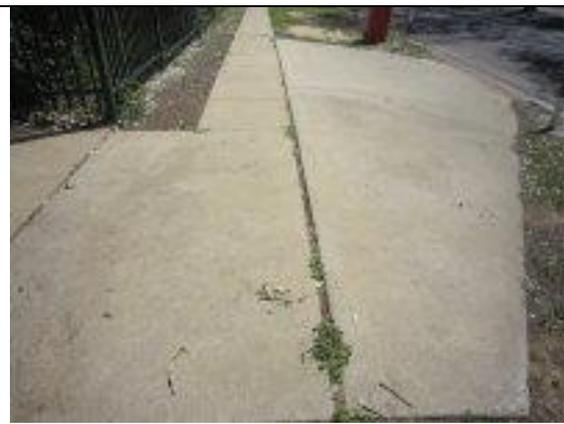
8. Wide joint in footway.

Wide joints have the potential to create a hazard for people who use a wheelchair or walking aid. The sealing of joints is considered to be a high need, low cost action.

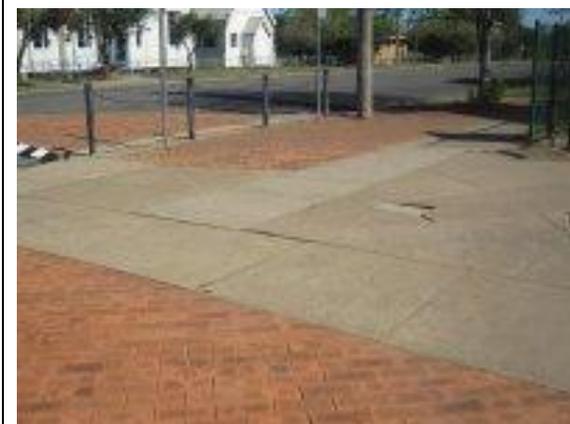
9. Telstra pit dropped at entrance to Church.

**5.05 Service pits (Photographs 9 and 10)**

Several locations are identified in the Access Audit Report where service covers and collars are damaged. Their repair by the appropriate Authority is considered to be a high need action, at relatively low cost to Council.

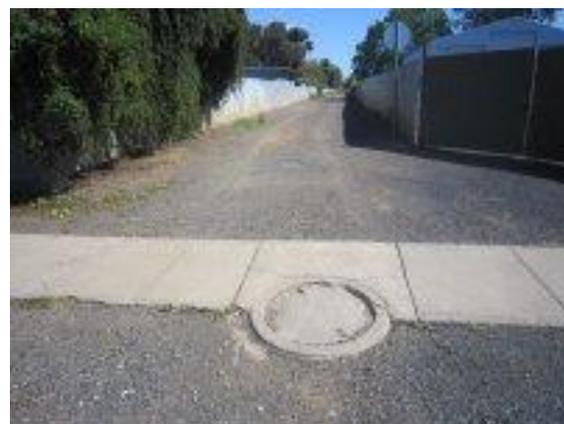
10. Manhole collar and lid damaged.

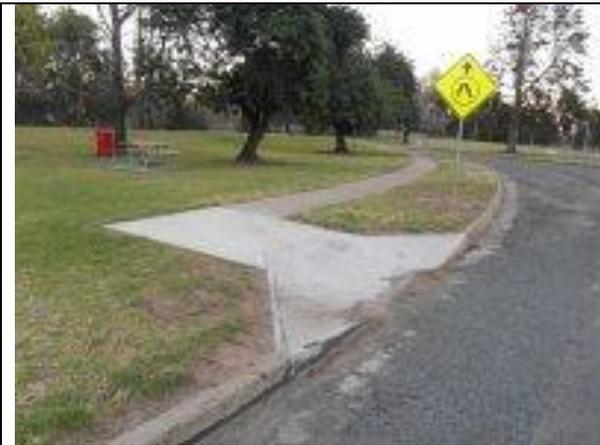
The importance of kerb ramps cannot be underestimated. Their location, design and construction in compliance with AS1428.1 (2009) not only ensures safe, equitable and dignified access for people of all ages and abilities, but reduces the incidence of potential accident claims against Council. **(Photograph 11)**

11. Correctly constructed kerb ramp.

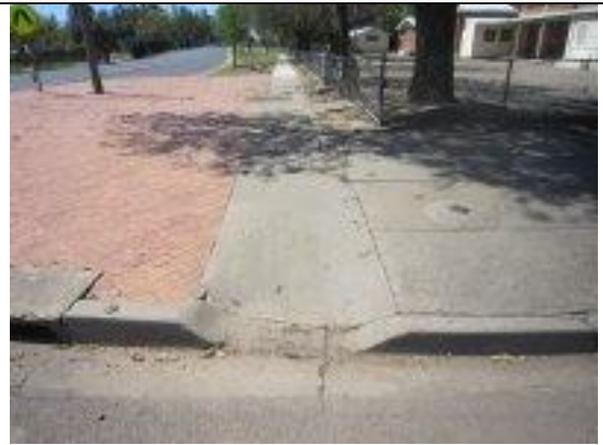
12. Narrow kerb ramp with steep splays.

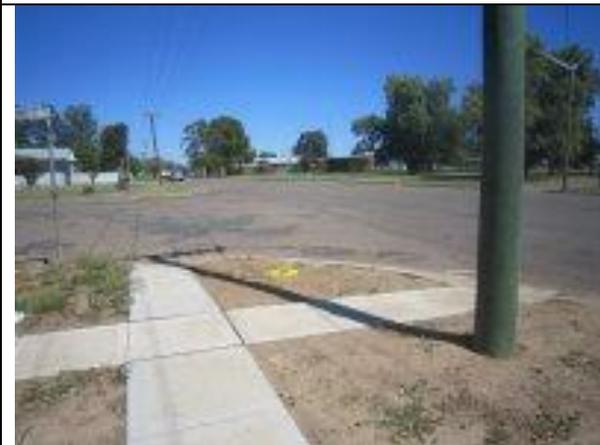
13. Radius kerb needs to be reduced to allow the construction of standard kerb ramps.

At other corner locations, where the construction of standard kerb ramps is restricted because of a large radius kerb, it is recommended that the radius be reduced, so that standard kerb ramps can be constructed on straight lengths of kerb.

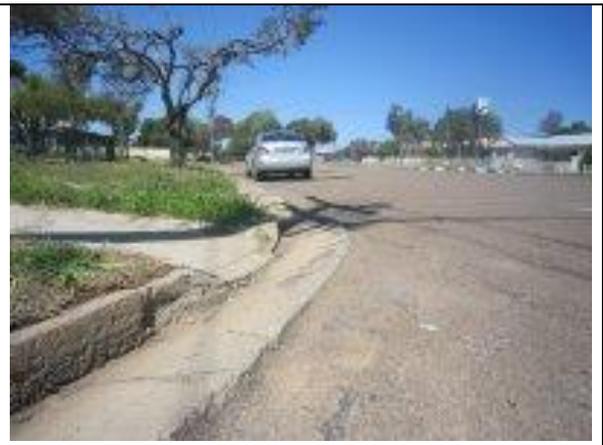
14. Kerb ramp and gutter are both very steep, creating a tip hazard for wheelchairs.

The existence of a lip at the base of a kerb ramp prevents some people who use wheelchairs from accessing the footway as the front wheel of a manual chair usually has a small radius and cannot mount the lip. If the kerb ramp is too steep some people will spend more time on the roadway while trying to access the kerb ramp, or while trying to find an alternate path of travel to the footway, thus increasing their safety risk.

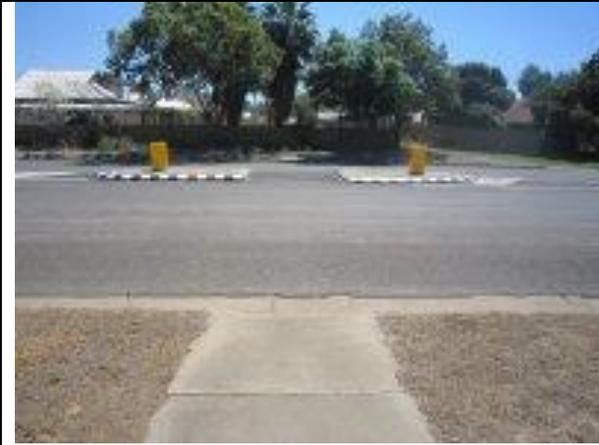
15. TGSIs should be placed within the walk-through or pedestrian refuge.

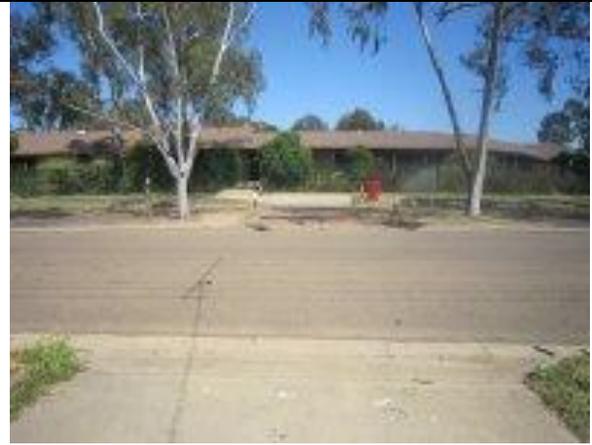
The walk-through should be at the same level as the roadway. A raised surface can present a potential trip hazard in the middle of the road for people with vision impairment, or for and aged people who tend to shuffle rather than lift their feet. **(Photograph 16)**

16. A walk-through at the same level as the roadway would assist people who use a wheelchair. TGSIs are required.

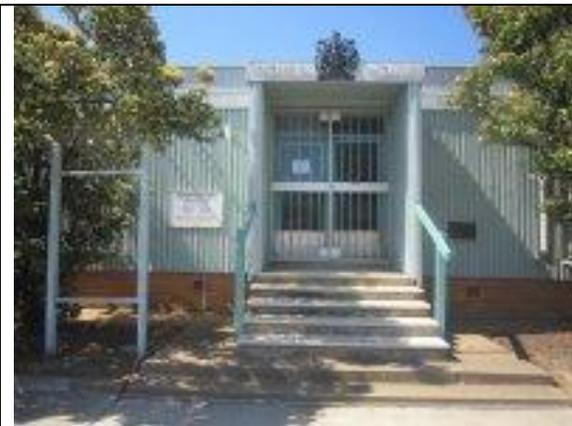
Ramps and steps require handrails on each side, so that a person who has an upper body or limb restriction has a choice of the handrail that best suits their ability.

17. Steps are required to have handrails on each side.

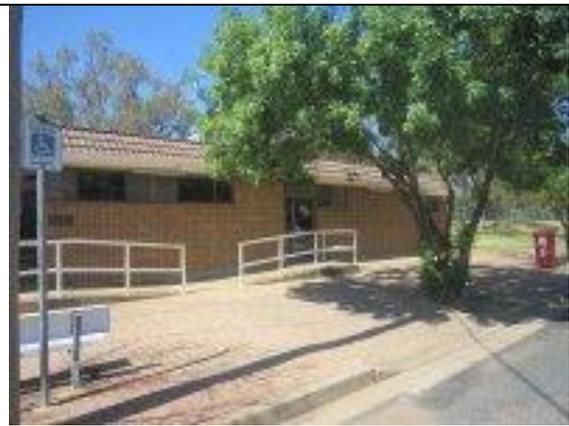
A lower rail is required on handrails, so that a wheelchair does not roll under the upper rail and become wedged. (**Photograph 18**)

18. Lower rail required.

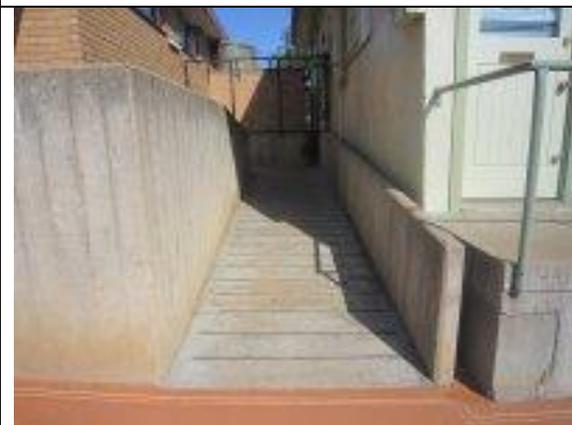
19. Handrails are required on both sides of a ramp.

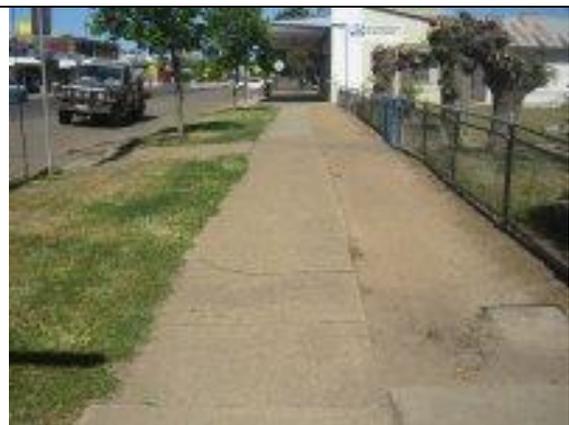
20. The bare surface at the side of the footway is lower than the footway level.

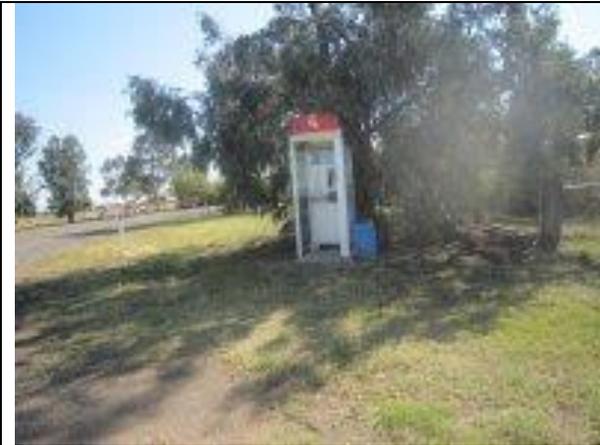
21. Public Telephone is not accessible. A hard-stand area, with circulation space 1540 mm X 2070 mm, is required in front of the door.

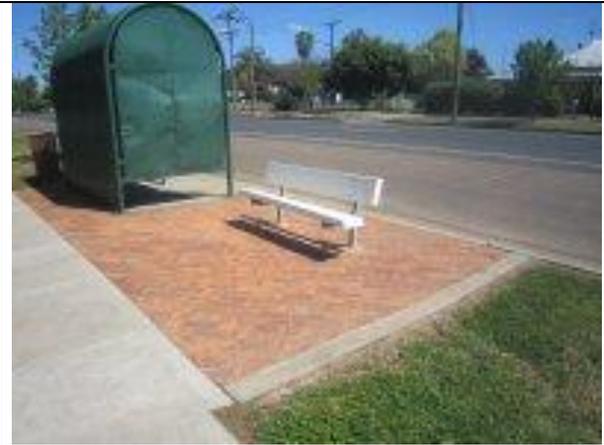
22. Seat at TrainLink Bus Stop requires an armrest.

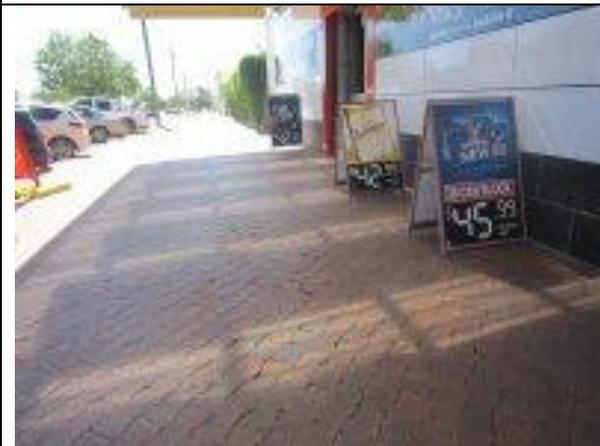
23. A- frames should be located on the outside of the footway.

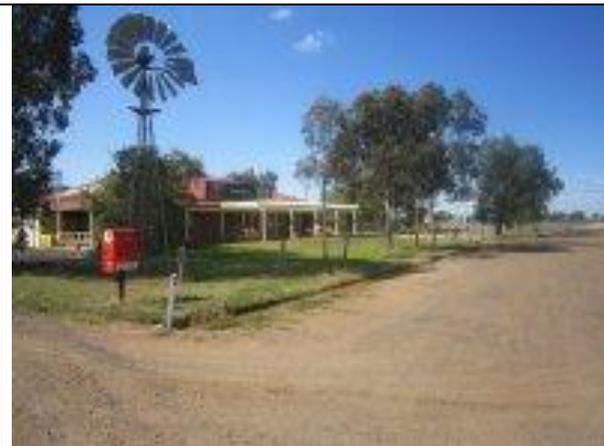
24. Public Posting Box is not accessible. A hard-stand area, with circulation space 1540 mm X 2070 mm, is required in front of the posting slot.

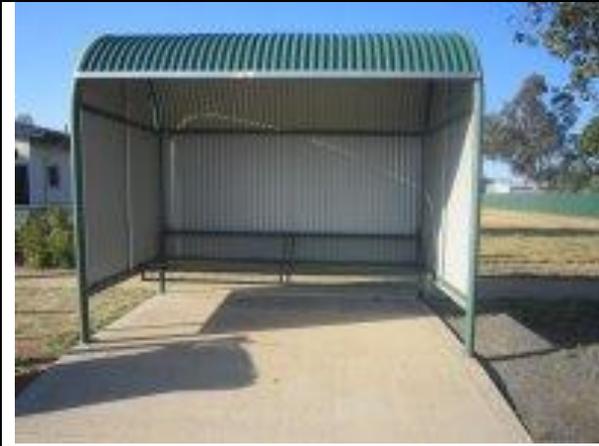
25. TrainLink Bus Stop on the northern side of the Mitchell Highway in Nevertire has no wheelchair space.

The TrainLink Bus Stops in Warren and Nevertire do not fully comply with the DSAPT. It is **recommended** that funding be sourced under the Country Passenger Infrastructure Grants Scheme to provide full accessibility to the Shire's three TrainLink Bus Stops.

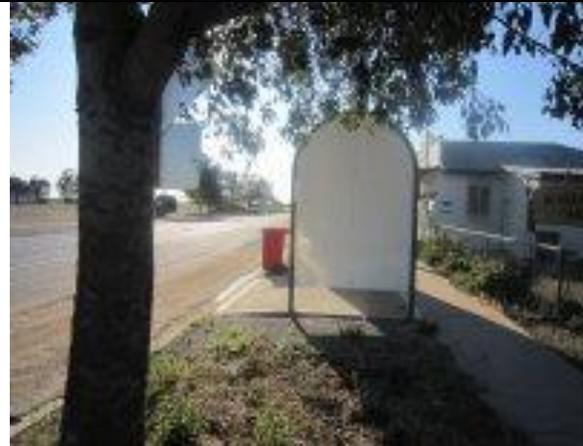
26. TrainLink Bus Stop on the northern side of the Mitchell Highway in Nevertire has a steep Boarding Point and no connecting path to the footway.

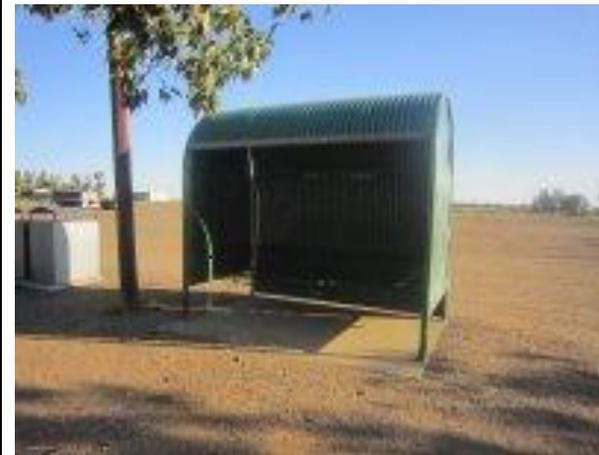
27. TrainLink Bus Stop on the southern side of the Mitchell Highway in Nevertire is not accessible.

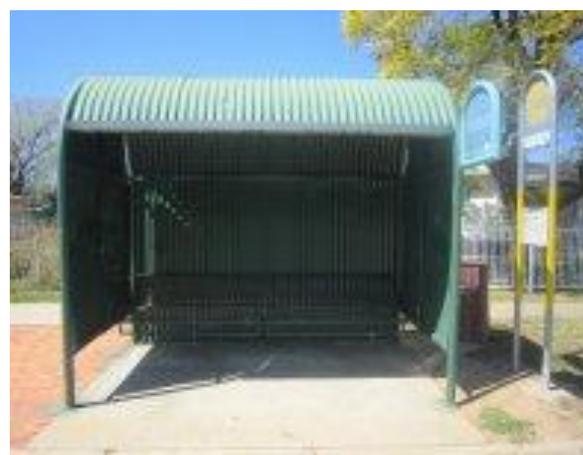
28. TrainLink Bus Stop on the eastern side of the Oxley Highway in Warren has no wheelchair space.

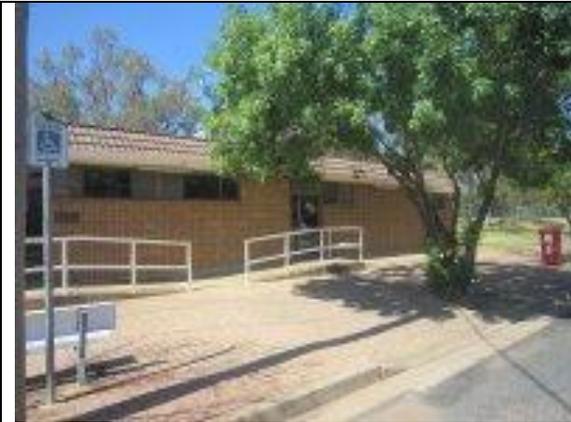
29. A parallel Accessible Parking Space near the Medical Centre, just west of the kerb ramp, is recommended.

Conversion of the angled parking Accessible Parking Spaces at the Dubbo Street Medical Centre and the Public Pool to parallel parking, would assist drivers with an upper body restriction. **(Photographs 29 and 30)**

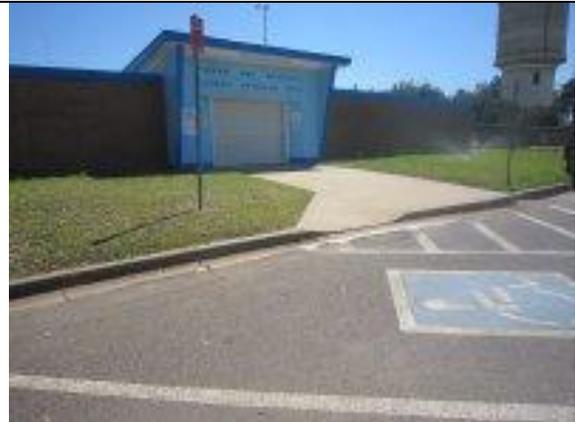
30. A parallel Accessible Parking Space near the entrance to the Pool, just south of the kerb ramp is recommended.

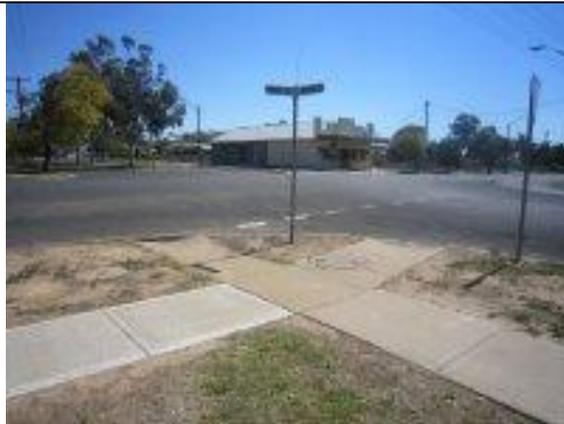
31. Street name signs at the same height.

When signs that indicate connecting streets are placed at the same height one is hidden from a driver's view by the other. A driver who slows down to try and view the other sign could become a hazard to other drivers or pedestrians.

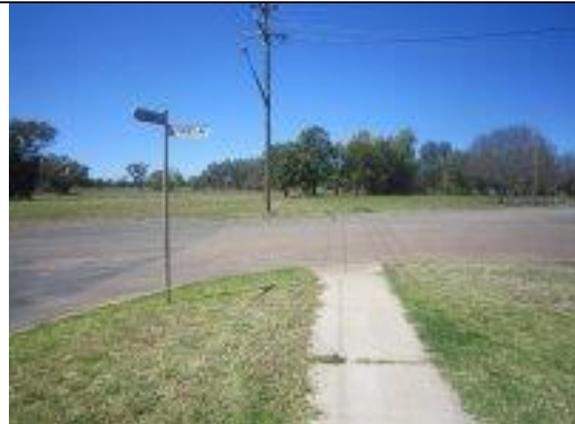
32. Street name signs located at different heights.

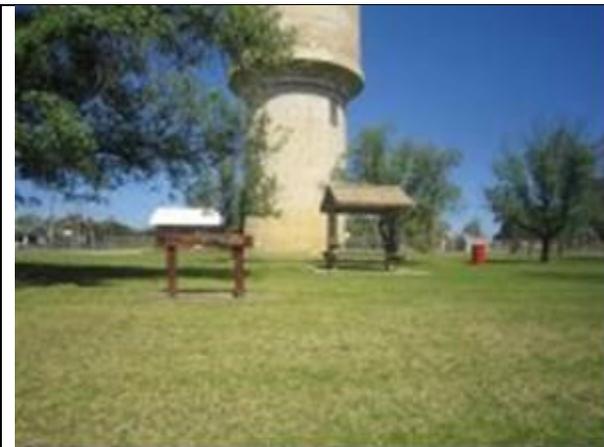
33. Picnic table not accessible.

- An accessible path of travel is required from the nearest footway to picnic facilities (**Photograph 33**)
- The accessible picnic table in **Photograph 34** allows a person who uses a wheelchair, or a toddler in a stroller, to be included at the table

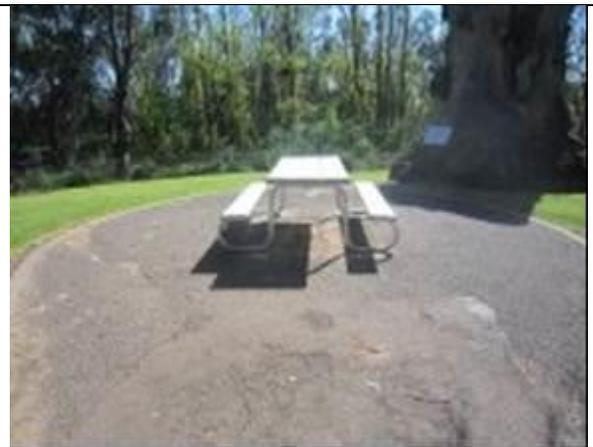
34. Accessible picnic table

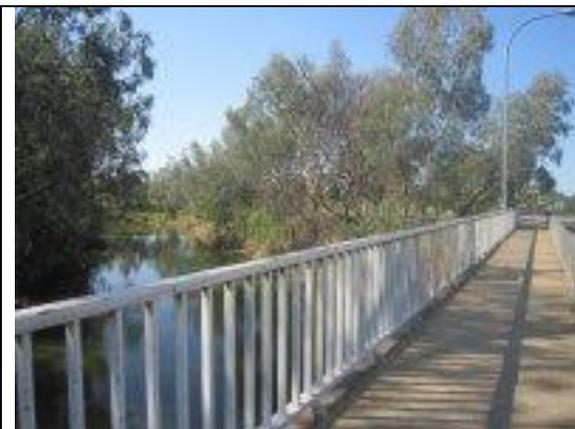
It was reported at the Community Stakeholders Meeting that there is a need for people who use wheelchairs or mobility scooters to travel to and from the Public Hospital, across the Bridge, and that passing on the Bridge has been identified as a problem. (The northern and southern footways on the Bridge are 1700 mm wide).

32. Macquarie River Bridge, north side, looking east.

It is **recommended** that Council submit a request to the NSW Roads and Maritime Services to widen both footways at the mid-point of the Bridge to provide compliant passing areas.

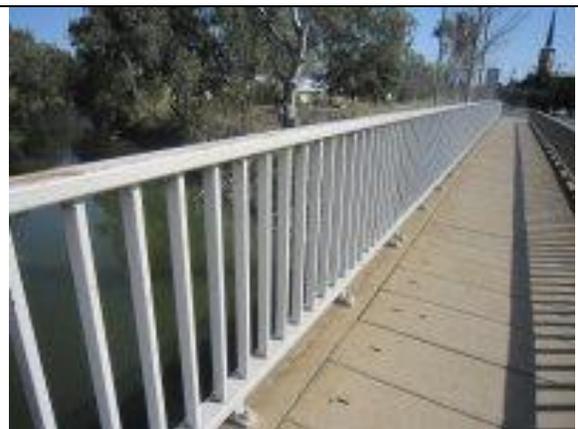
33. Macquarie River Bridge, south side, looking west.
